Contract #: 04-0120F4Cty: SF/ALA Rte: 80 PM: 13.2/13.9File #: 69.28**WELDING INSPECTION REPORT****Resident Engineer:** Pursell, Gary**Address:** 333 Burma Road**City:** Oakland, CA 94607**Report No:** WIR-001331**Date Inspected:** 25-Jan-2008**Project Name:** SAS Superstructure**OSM Arrival Time:** 1730**Prime Contractor:** American Bridge/Fluor Enterprises, a JV**OSM Departure Time:** 600**Contractor:** Zhenhua Port Machinery Company, Ltd (ZPMC), Changxing Island **Location:** Shanghai, China

Bridge No: 34-0006**Component:** plate subassembly**Summary of Items Observed:**

WELDING INSPECTION REPORT

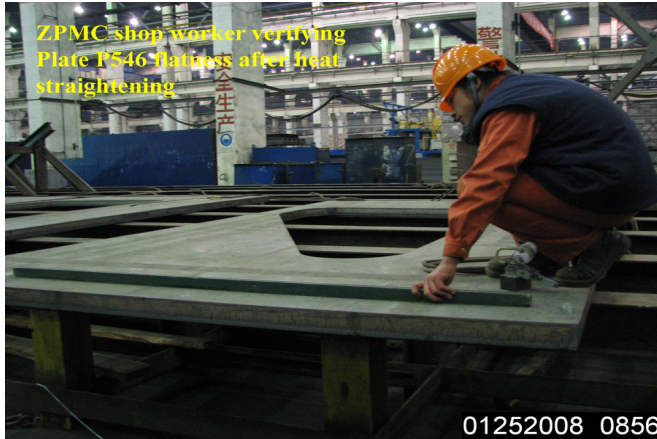
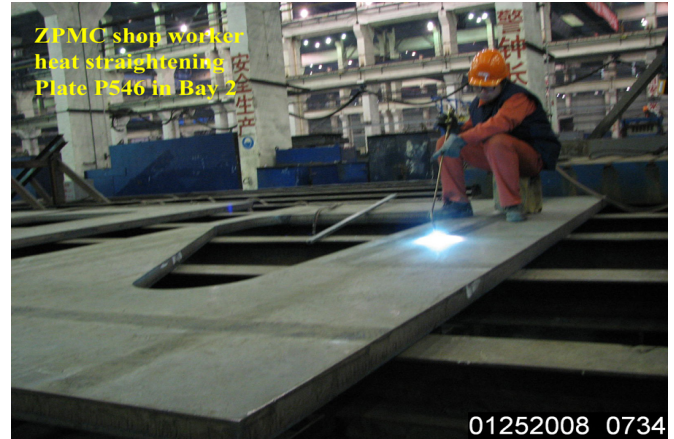
Caltrans QA Inspector witnessed the heat straightening of plate identified as P546, in Bay 2, per ZPMC approved shop heat straightening procedure. Caltrans QA Inspector inquired if Caltrans Engineering approval is required. ZPMC Quality Control (QC) Inspector, Mr. Zhang Jiadi stated that the plate was within 3/1000 deviation; requiring no engineering approval for heating straightening. Caltrans QA Inspector requested to see ZPMC work instruction document for performing the heat straightening. Mr. Zhang Jiadi stated that the maximum deformation is about 2mm's and the document is unavailable at the time of Caltrans QA Inspector's observation. Caltrans QA Inspector ZPMC shop worker applying heat with the use of a hand held oxygen/fuel flame type torch. ZPMC monitored the applied heat to the plate, with the use of a hand held device, identified as an infrared laser temperature gun. Caltrans QA Inspector randomly observed that the maximum heat being applied to the plate is approximately 550 Celsius. The shop procedure states, maximum heat to be applied, 650 Celsius. The heat straightening of the plate appeared to be in general conformance with the shop procedure and contract documents. Following digital pictures illustrate method and verification of the heat straightening of the plate.
